QA-106
Silk Farm
Centreville vicinity
Private

INVENTORY FORM FOR STATE HISTORIC SITES SURVEY

Silk Farm

QA-106

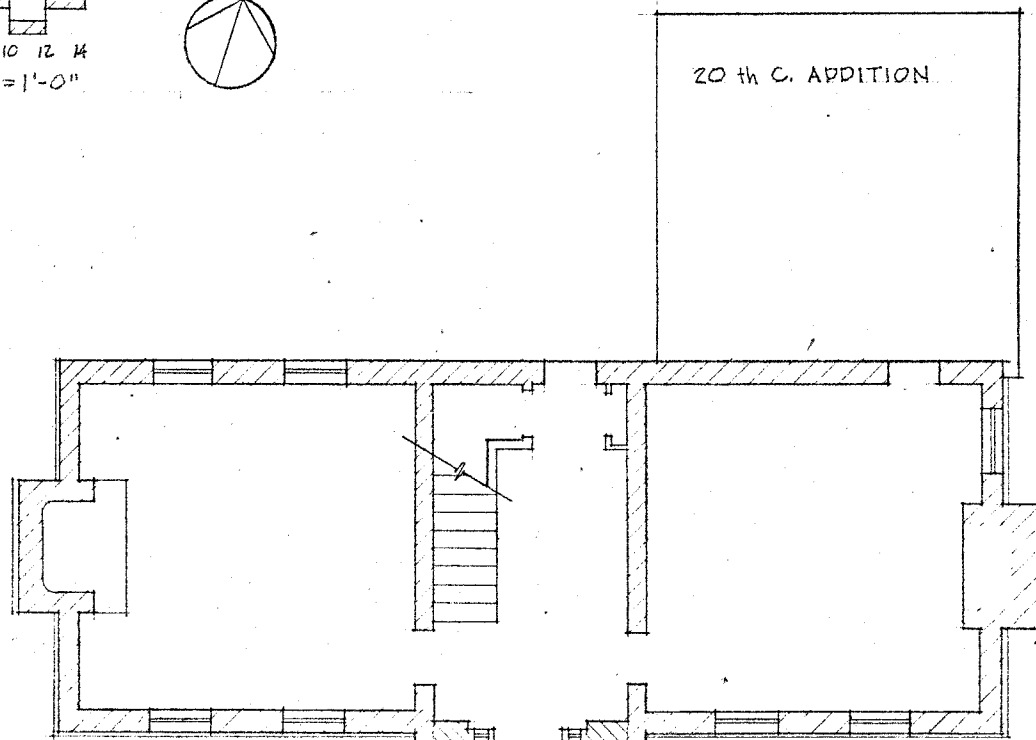
SILK FARM
CENTREVILLE, MARYLAND

PERIOD I: 18th C.
PERIOD II: C. 1840

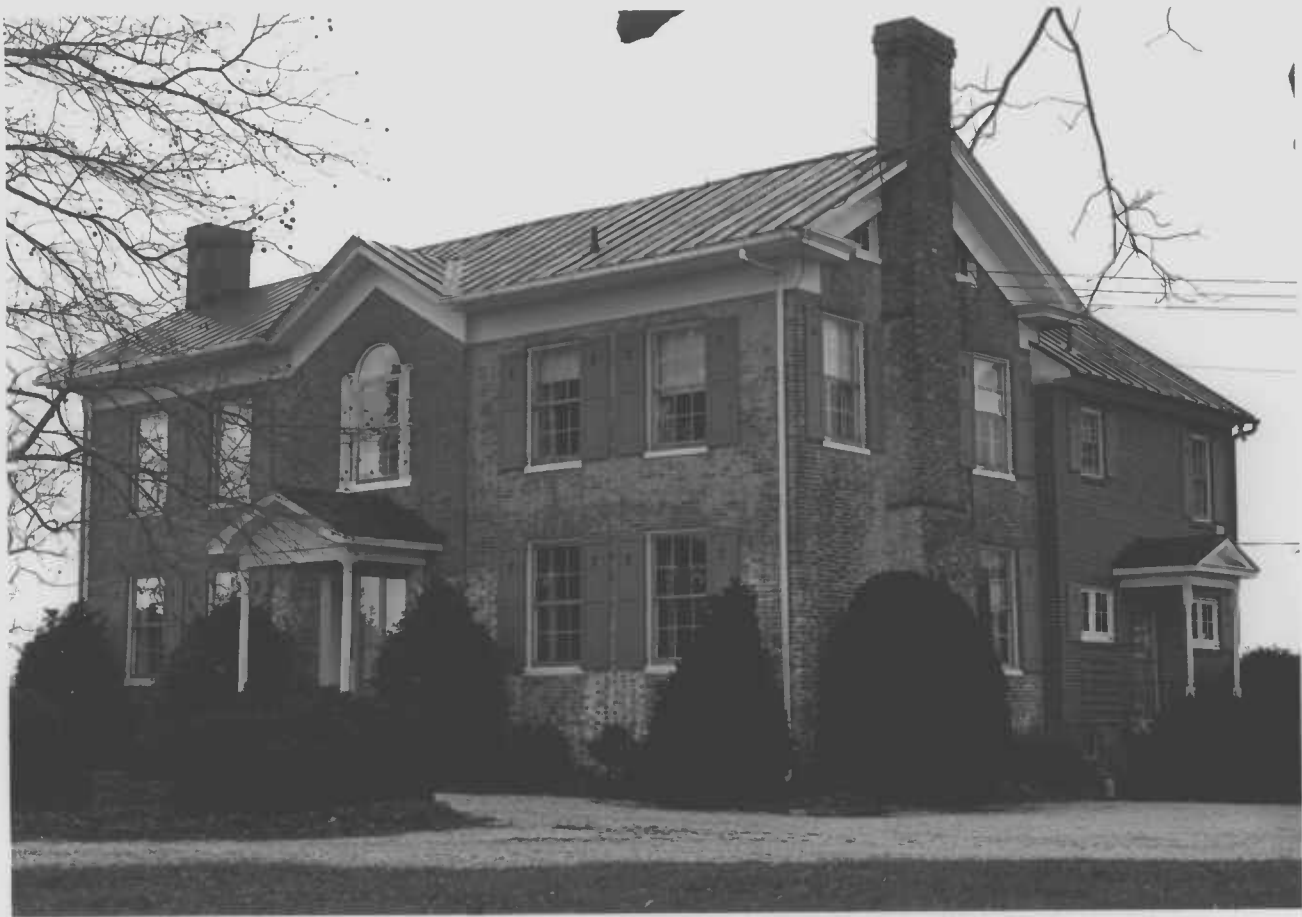
Silk Farm
Centreville vicinity
Orlando Ridout V 1979 (MHT)
Front facade, from SE

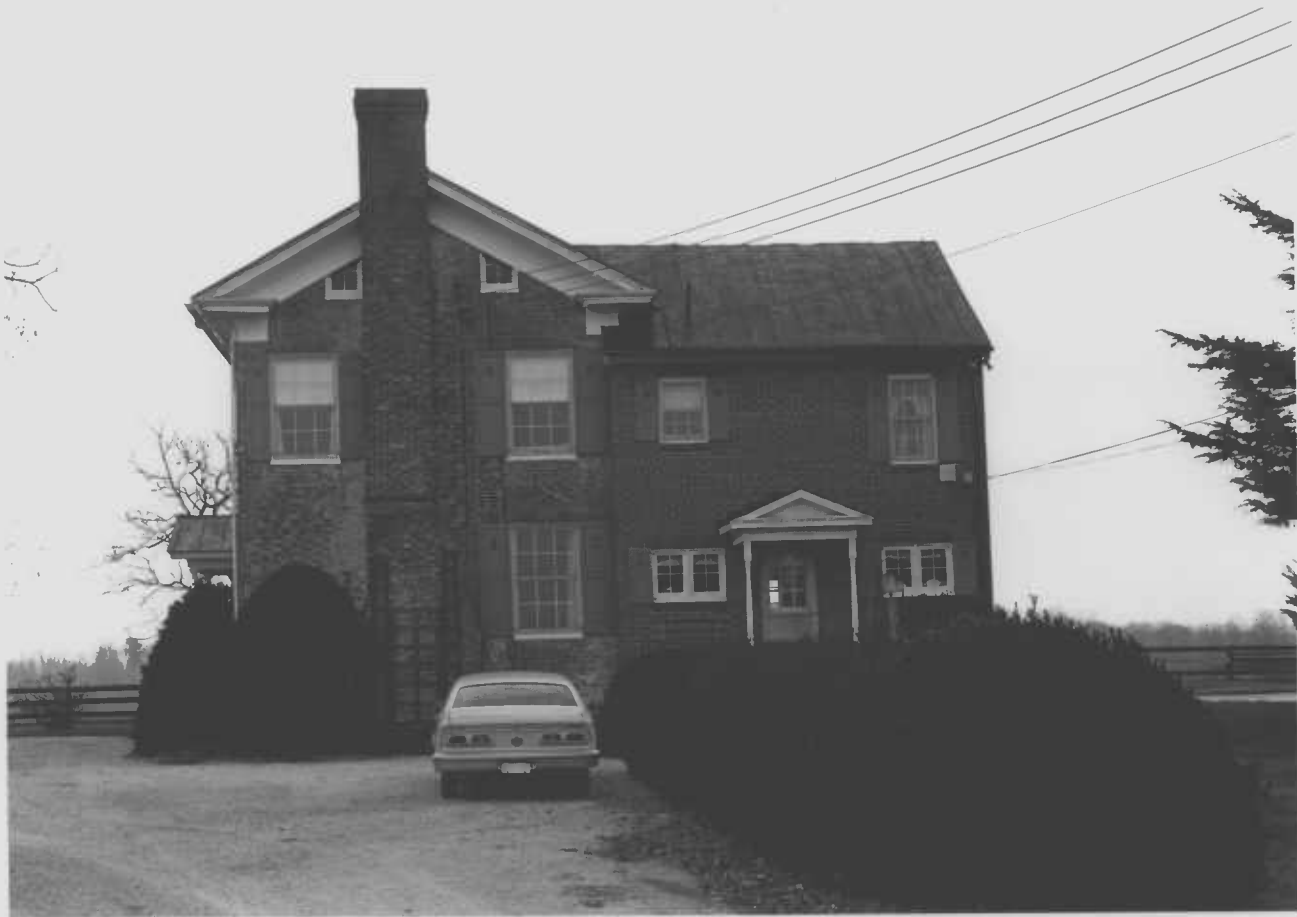
The east gable has been partially rebuilt, with repairs made to the northeast corner, and a window has been inserted on the first floor and to the cellar.

The east gable has been partially rebuilt and a six-over-six window has been inserted to the right of the chimney on the first floor. A large cellar window has been cut in below the first floor window. A pair of six-over-six windows flank the chimney on the second floor, and a pair of small four-light windows flank the chimney in the upper gable. The cornice treatment is similar to the west gable, except that the fascia board partially blocks the upper corners of the small gable windows.

Silk Farm
Centreville vicinity
Orlando Ridout V 1979 (MHT)
East gable

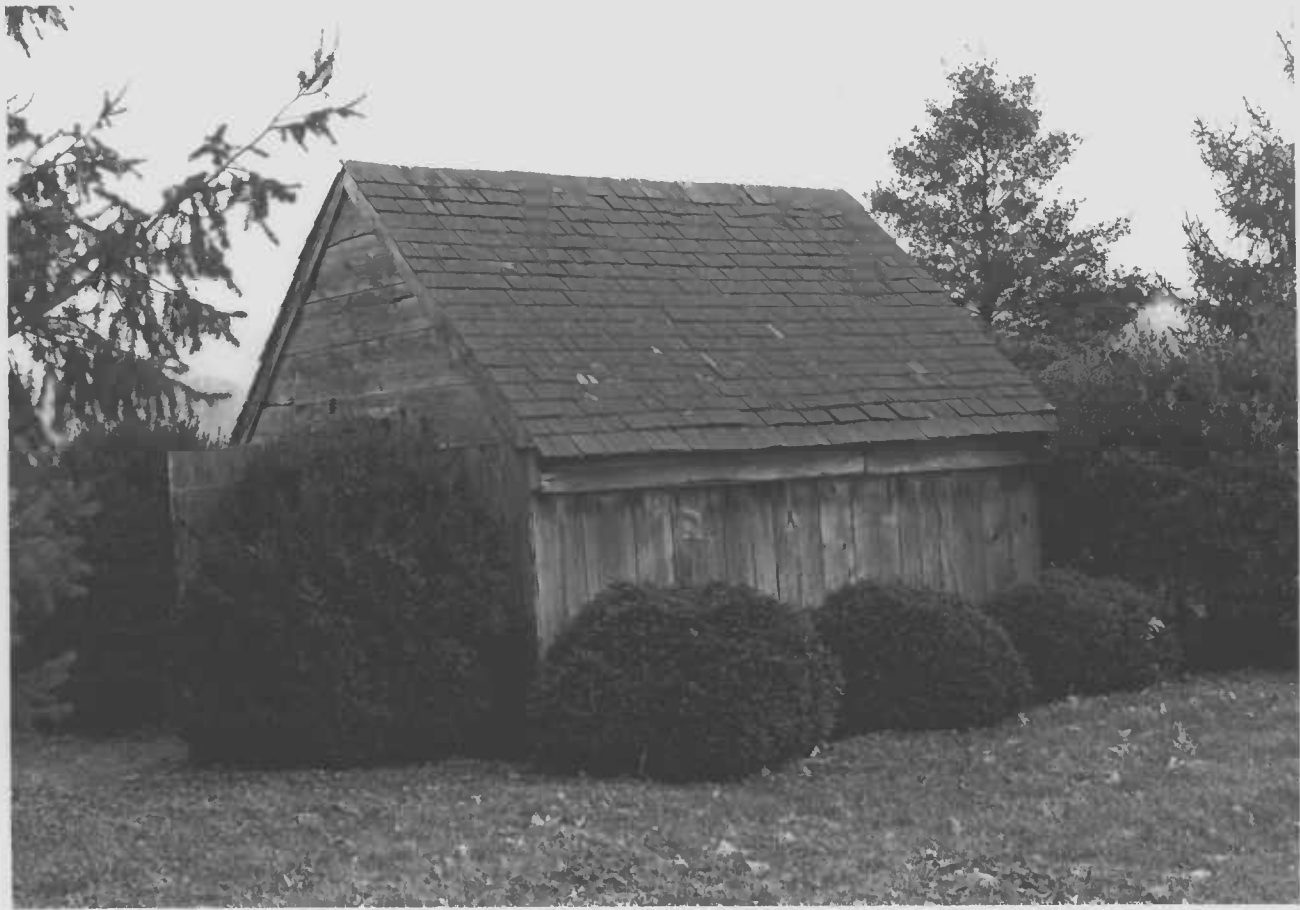
There is a small log meat house to the east of the dwelling house. This building is 13 feet long by 12 feet wide. It is constructed of hewn and pit sawn log planks with dovetail corner notching. The planks average $9\frac{1}{2}$ to 12 inches wide and $2\frac{1}{2}$ to 3 inches thick. These are closely set, leaving narrow cracks which show no evidence of having been chinked or plastered. The gable top plates and two intermediate ceiling joists are notched over the side wall plates, dividing the interior into three bays. The two

The exterior has been covered with plain vertical weatherboards secured with machine nails. The upper gables have been sheathed with horizontal siding secured with machine nails. The roof is 40 degrees in pitch, and is covered with wood shingles. Tapered rakeboards and a box cornice with beaded fascia board add a touch of refinement. The door is in the center of the north gable. This is constructed of plain vertical boards nailed to "Z" battens with machine nails. It is hung on heavy wrought strap hinges.

Silk Farm
Centreville vicinity
Orlando Ridout V 1979 (MHT)
Log plank meathouse

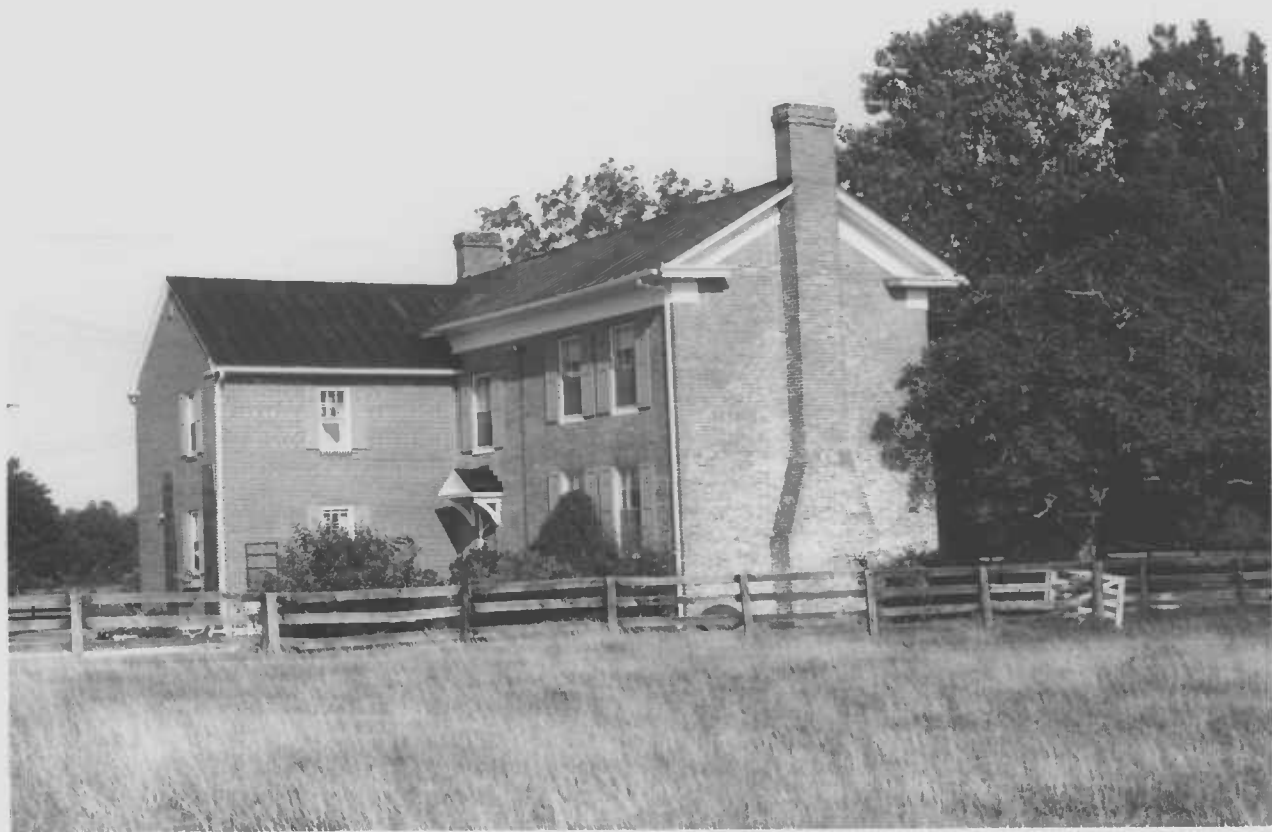
The rear facade dates almost entirely to the second period of construction. The early brickwork remains in the lower west end of this facade, but has otherwise been replaced. The two east bays are covered by a recent two story brick wing. The door is located in the center bay, set slightly off center to the east to allow room for the stair. There are two six-over-six windows to the right of the door on each floor, but these are not symmetrically ordered.

View from NW

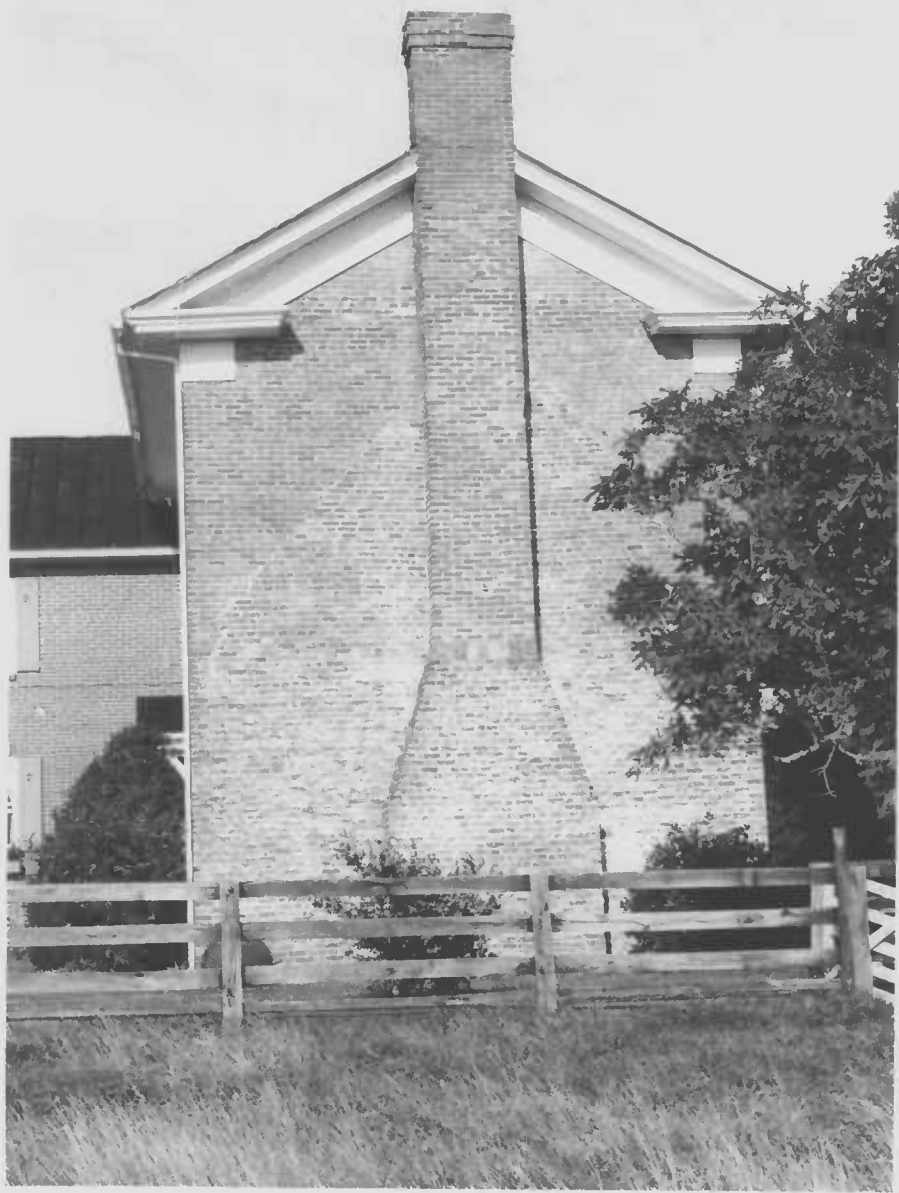
The west gable is dominated by a large exterior chimney with tiled weatherings and corbeled shoulders. There are no openings in this wall, but a subtle change in brick color in the upper gable suggests that there were originally one or perhaps two small windows flanking the chimney.

The west gable remains relatively unchanged, except that it has been raised to two stories. The cornice returns at the gable and is carried up the gable eave.

West Gable

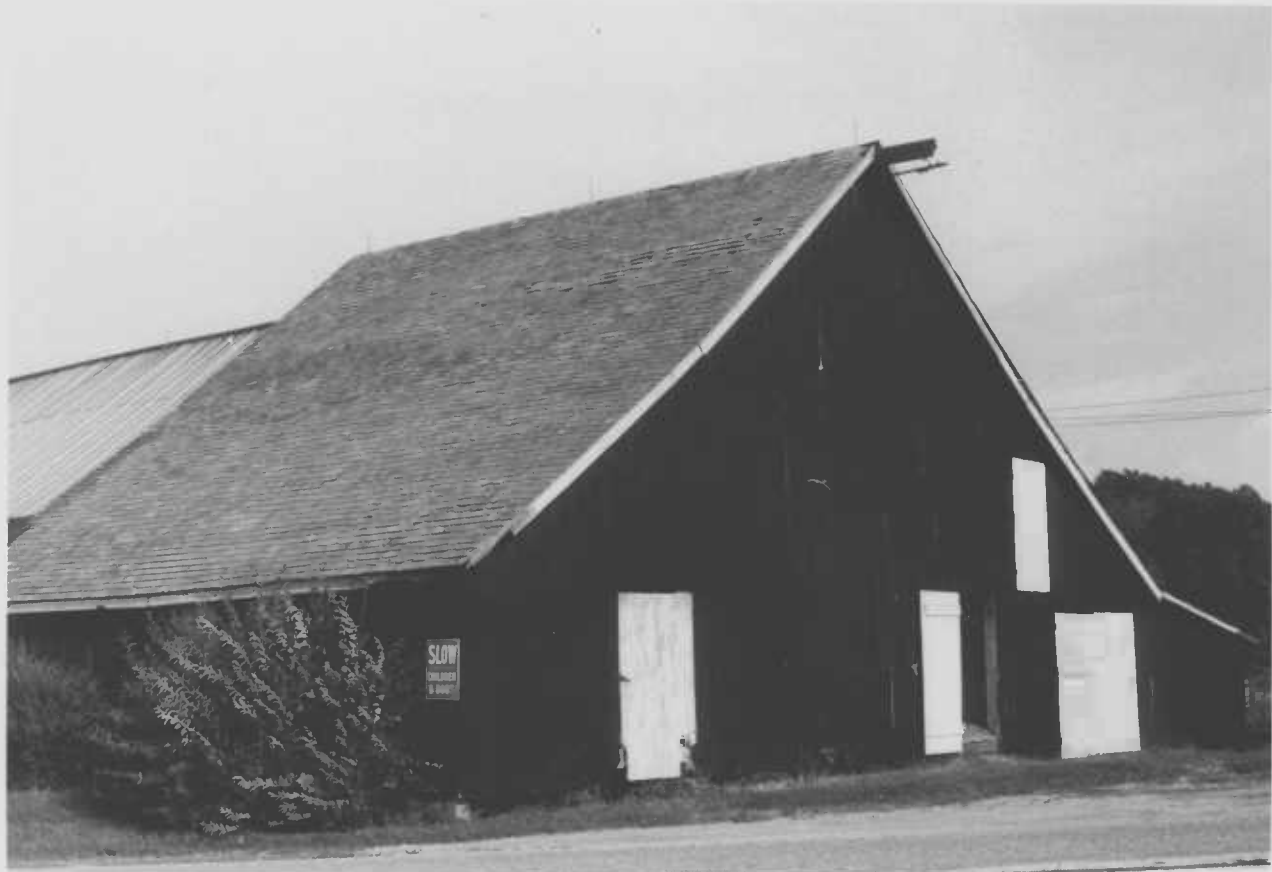
Barn from northwest
